**Assessment of illegal damages caused
by Belize Hydroelectric Development
and Management Company Limited
within the Bladen Nature Reserve &
Columbia River Forest Reserve**

**Produced by the Ya'axché Conservation Trust and
Wildtracks**

October 2009

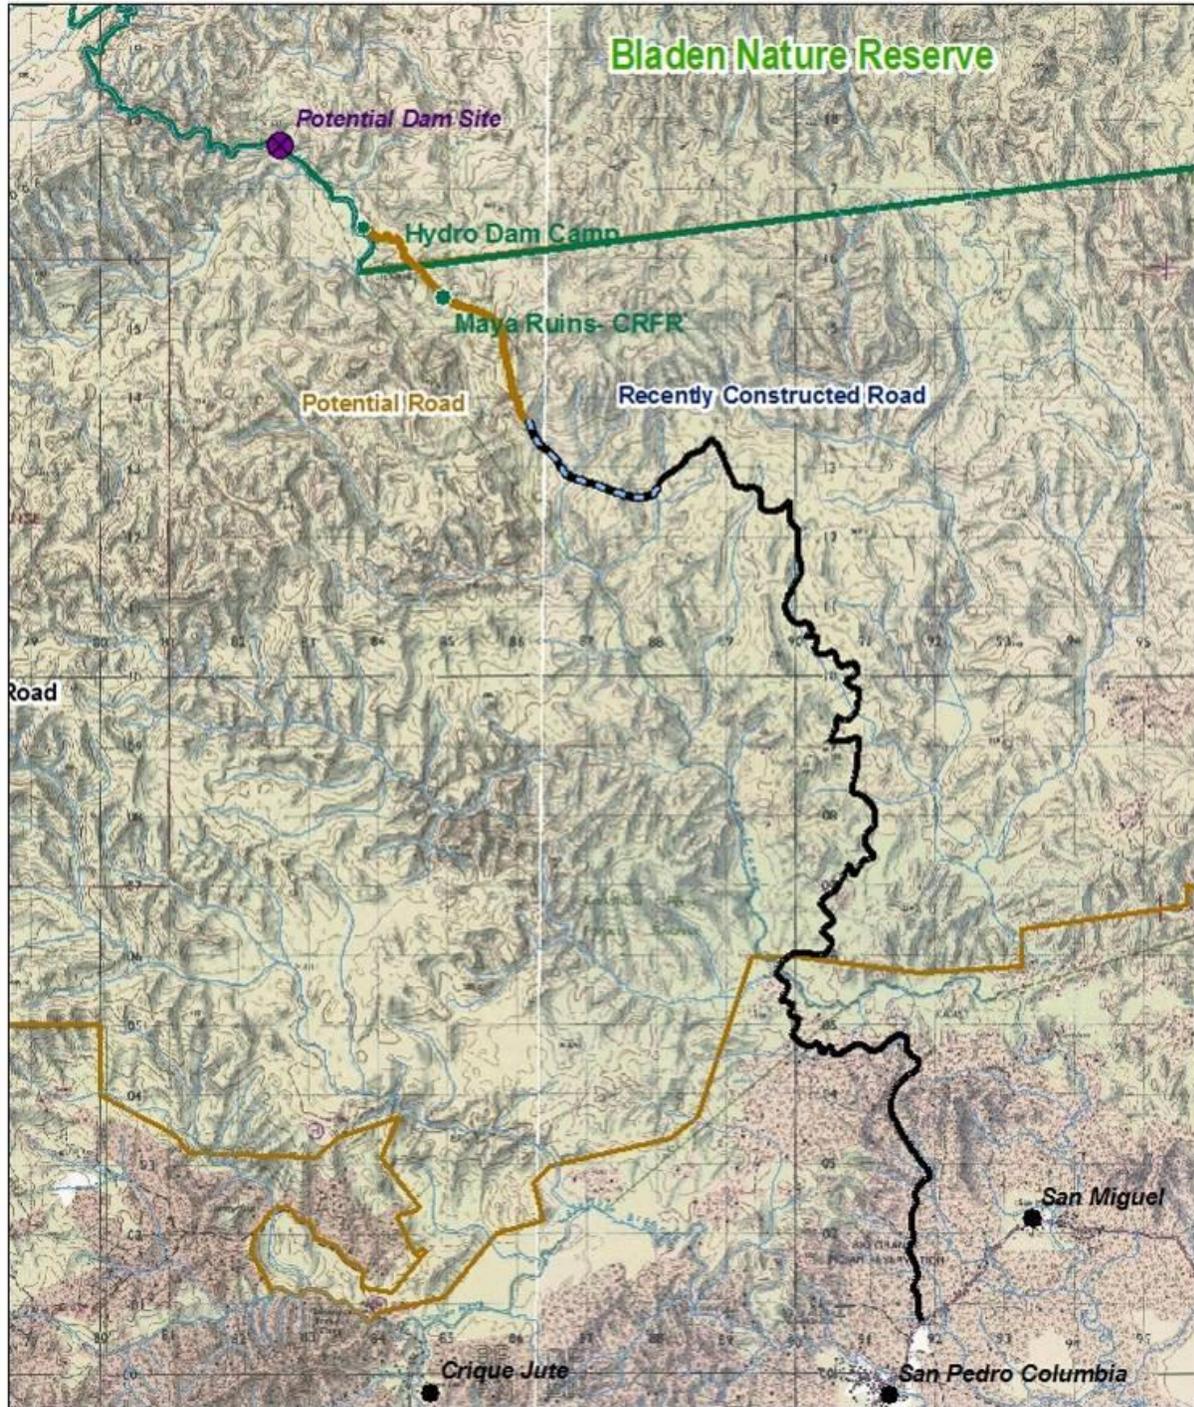
Appendix 1. Map of Columbia River Forest Reserve and Bladen Nature Reserve demonstrating sites impacted by BHD.

As shown in figure 1, approximately 13.25 miles of existing logging roads from 291814 1800749 to 289307 1812711 were reopened within the Columbia River Forest Reserve. These roads already impacted from previous logging operations are covered in grass and herbaceous plants. Of greater consequence was the opening of approximately 1.5 miles of new access road from 289307 1812711 to 287989 1812711 and an approx. 2.5 mile long trail from 287989 1812711 to 283907 1816343. Trees and vegetation were cut down and pushed to the side, clearing an area that was on average about 12 feet wide, but in at least 7 instances widened to over 40 feet or more. Numerous large trees were observed to have been cleared from this area, from a

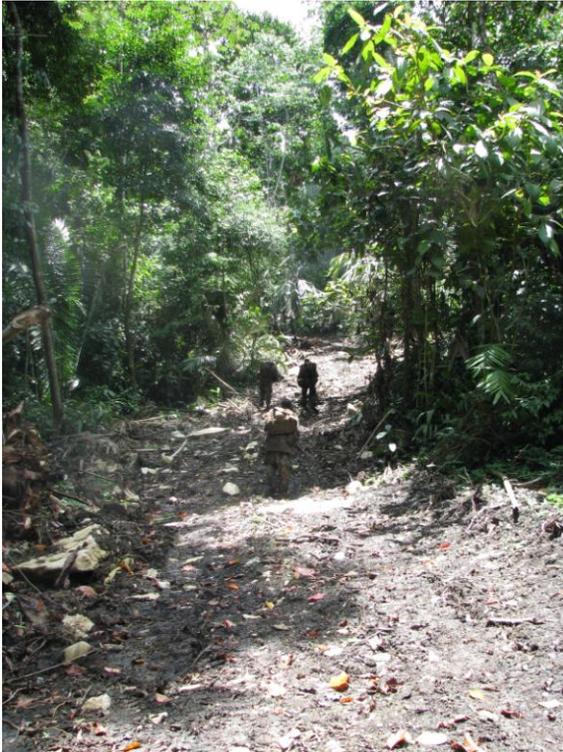
On at least 6 slopes of approximately 40°, vegetation was cleared for road access and several more of between 20° to 40° which is prohibited under Forest Department policy. It was noted that along these steep slopes, surface run-off was extremely swift and was responsible for very high levels of sediment run-off into nearby creeks, which will eventually flow into the Rio Grande. Moreover, this run-off was also eroding the sediment along the road, removing soil and forming deep drains which shall inhibit natural regeneration if left unaddressed.

Figure 1. Road clearance on steep slope 1

On steep slopes that have been cleared, high levels of erosion will occur under the area's heavy rainfall leading to the loss of top soil and general lack of slope stability thereby inhibiting natural forest regeneration. To address this, the installation of water bars is recommended. These are ditches and/or humps placed across a road as a relatively cheap and cost-effective mechanism for reducing the overall speed of surface water run-off thereby reducing soil loss and stabilizing bare slopes. It is very important that these are installed correctly otherwise they will be ineffective or possibly even detrimental.

Ideally someone experienced in the construction of water bars should supervise the installation of these, but failing that, numerous free online resources are available which document effective techniques for constructing these. Due to the steepness of the slopes, the loose top-soil and substrate and high rainfall, it is recommended that water bars are spaced at the following intervals. It is estimated that at least 60 water bars would be needed to control erosion on the slopes.

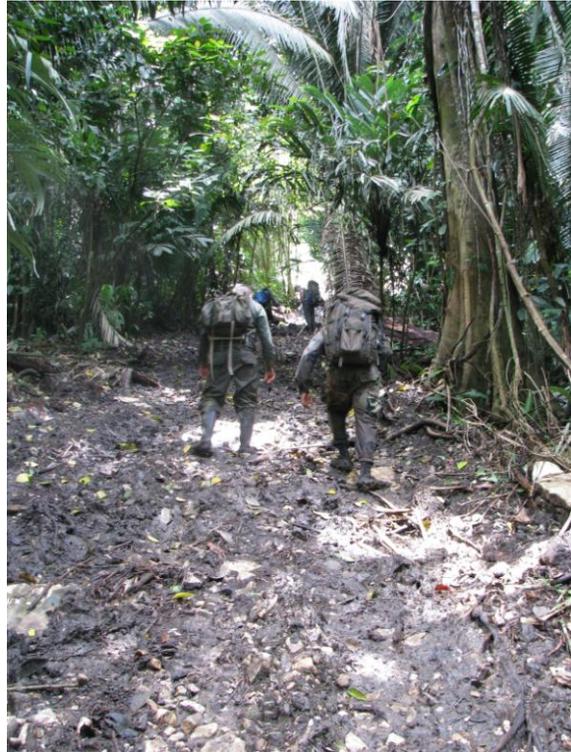
Figure 2. Road clearance on steep slope 2

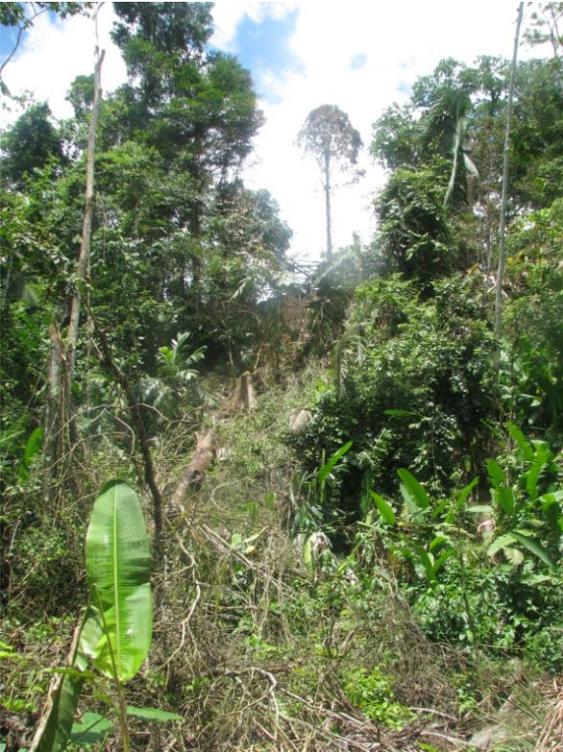
A camp site within BNR at coordinates 283907 1816343 covering a total of 5830 square feet was cleared of all vegetation. Beside the camp a 45° slope, approximately 100 feet wide was cleared of vegetation for approximately 80 feet down towards the Central River. The rationale for this is believed to have been to provide a view of the river and possibly also as a helicopter flight approach. This is likely to result in increased erosion directly into the Central River & Rio Grande, particularly when bank failure occurs under the heavy rains that the area encounters. Moreover, this clearly violates Forest Department policy of leaving a 66 foot riparian buffer beside all water bodies.

Figure 3. Slope cleared above Central River

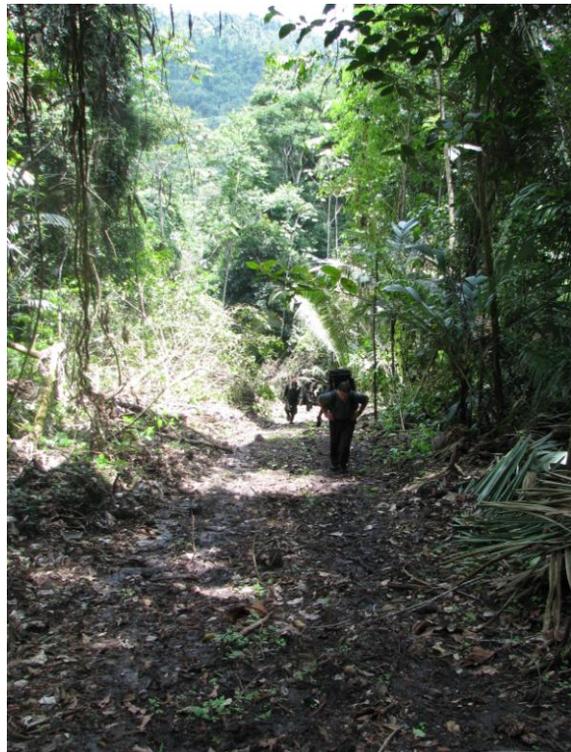
Figure 4. Road clearance on steep slope 3

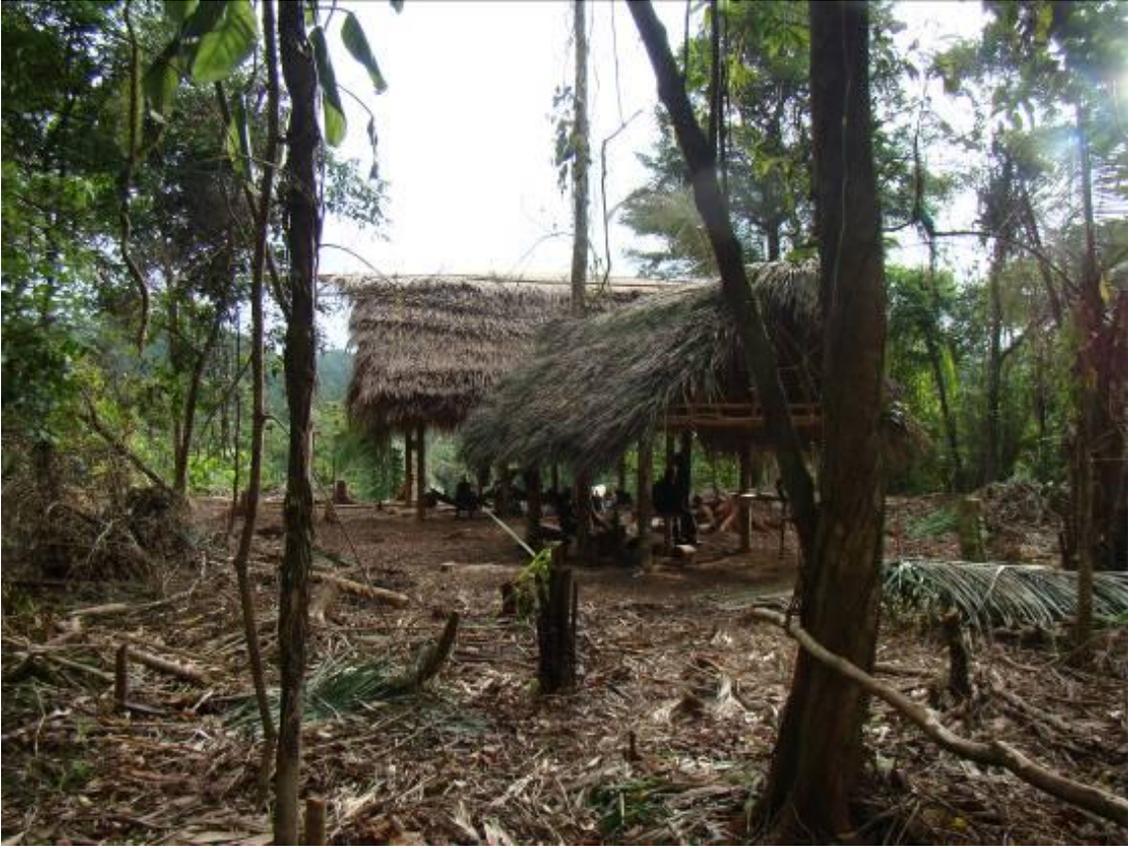
from the perimeter of what was actually cleared for the camp. In total, an estimated total of 350 cohune leaves were gathered from the area surrounding the camp, for the construction of the two thatched palapas (Figure 5).

Figure 5. Thatched palapas constructed within BNR

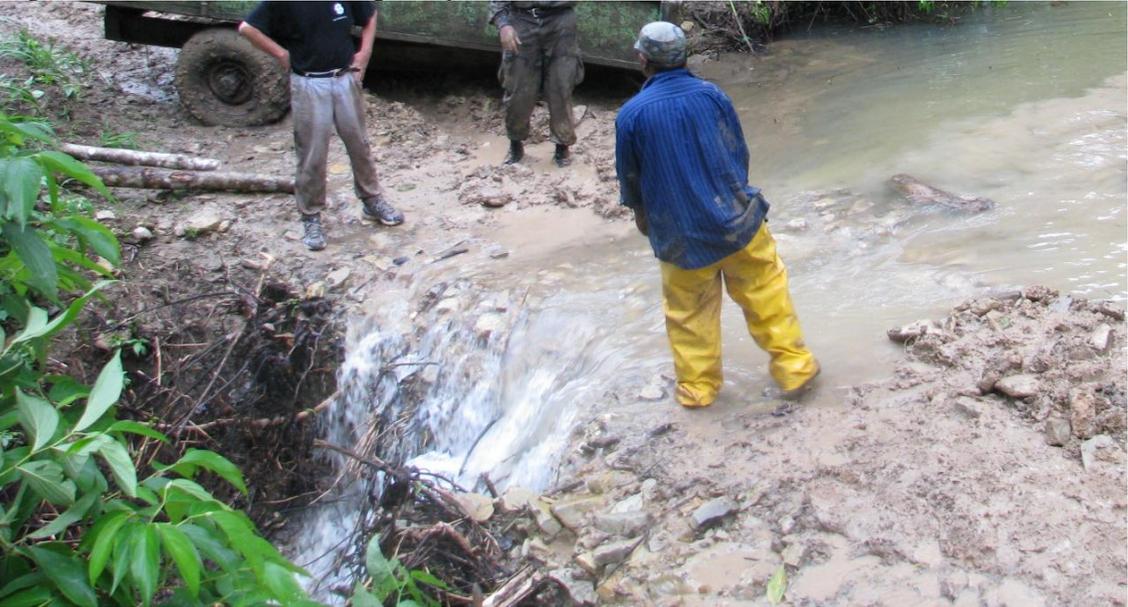
During the (re)opening of roads at least 4 waterways were blocked forcing water to flow over the top of the blockage and creating ponds. Forest regulations normally stipulate that culverts must be constructed to facilitate water flow in a relatively normal manner. These blockages contribute to the erosion of creek banks and siltation of the creeks themselves.

Figure 6. Blocked creek along entry road

It is also advised that all blockages, placed within creeks during the construction or re-opening of roads, be removed to reduce the amount of sediment entering waterways and restore normal hydrologic regime.

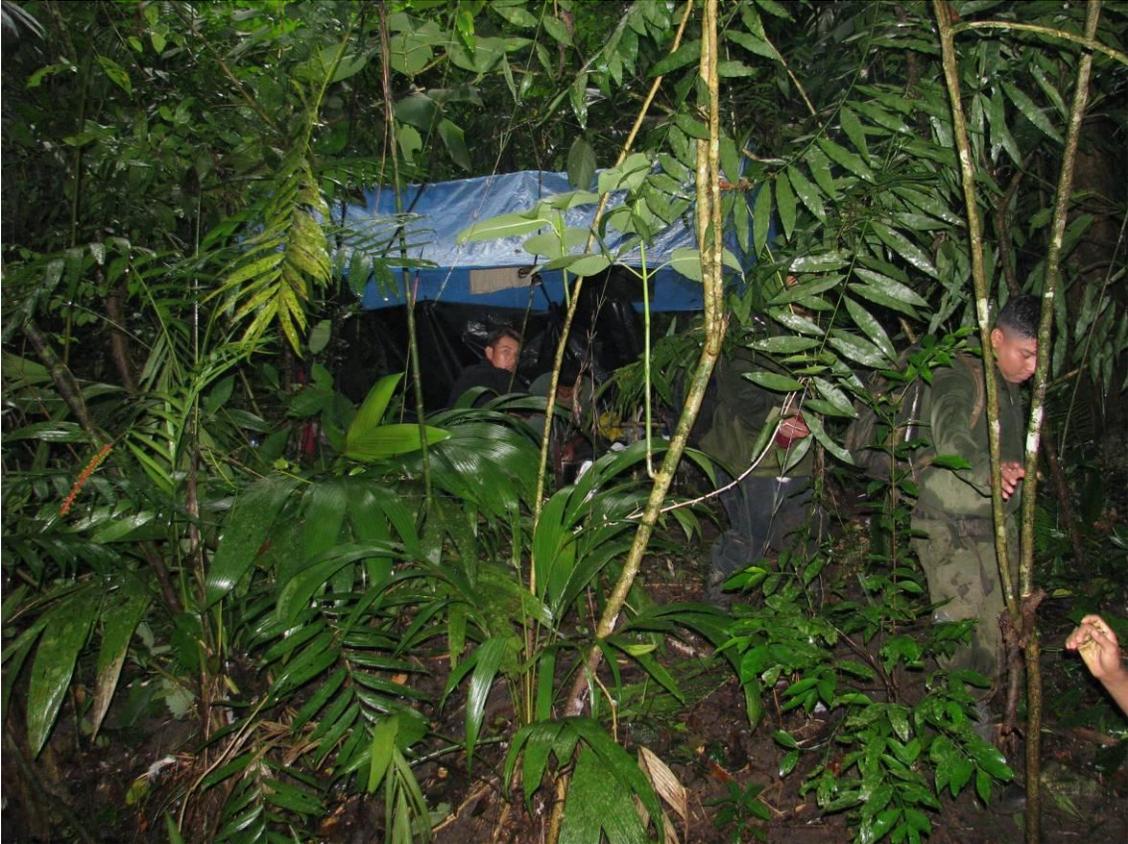
In clearing the road, accessibility to the Bladen Nature Reserve and northern CRFR was greatly increased. This was observed to have facilitated the entrance of hunters from the village of San Pedro Columbia who were found to be camping only a few kilometres away from the BHD campsite (Figure 7). Experiences from other areas within CRFR indicate that once a trail is opened it is very difficult, if not impossible, to close the trail as hunters and other users will keep the trail open. The assessment team noted numerous shells along the road, demonstrating that opening up of the area will be responsible for the depletion of local wildlife populations. Moreover, these trails link up with xatéro trails running from the Guatemalan border, facilitating access by both Guatemalans further south into the CRFR as well as by Belizeans throughout BNR and CRFR.

Figure 7. Belizean hunters camping within CRFR enabled by increased accessibility

Due to the increased ease with which local community members can access the reserve, several measures need to be taken to address this. The first is the installation of a gate at the entrance to CRFR to stop unauthorized vehicles from entering the reserve, alongside the establishment of signs at this entrance and along the route indicating that entry without permits is illegal and trespassers may be prosecuted. This will need to be supported by patrols by a dedicated team of 3 rangers within the area to monitor and control illegal activities.
